# SELECTING PIPE FITTINGS FOR GOLF COURSE IRRIGATION SYSTEMS

By Bill Koonz Jr., CID

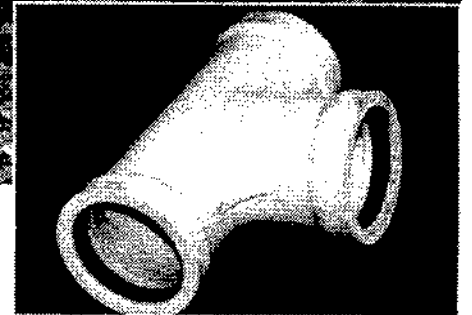
**Above right: Pressure surges cause persistent expansion and contraction of PVC fittings that lead to a rupture in the fitting. Data from testing shows PVC molded fittings fail after only 16,000 cycles, compared with 1.5 million cycles for PVC pipe.**

diameter, injection-molded PVC fittings under cyclic surge conditions indicate the tensile strength of these fittings declines greatly in a short period of time. As discussed earlier, PVC pipe can withstand more than 1.5 million cycles before failing. PVC injection-molded fittings began to fail under these conditions after only 16,000 cycles. The three researchers concluded that the "fittings are the weak link in terms of their ability to withstand fatigue cycles that involve large pressure differences."
